Regarding: Completed Reserve Analysis (Stratton Flats Master Association #5587)

Stratton Flats Master Association

Level 1, Premium Reserve Analysis

Date of Property Observation –January 9, 2015

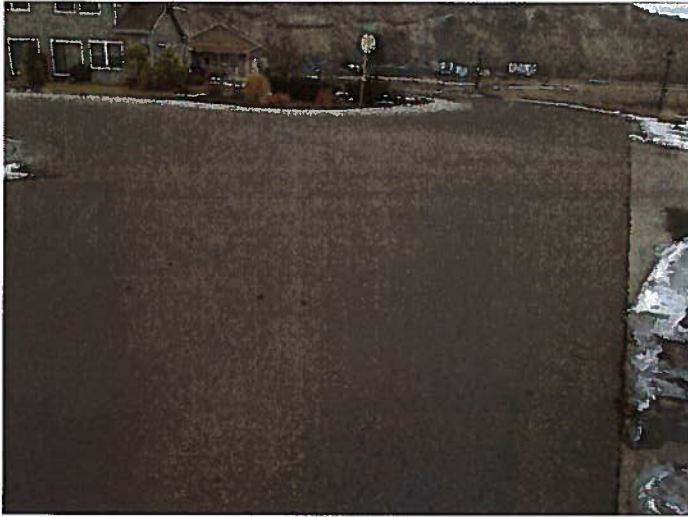
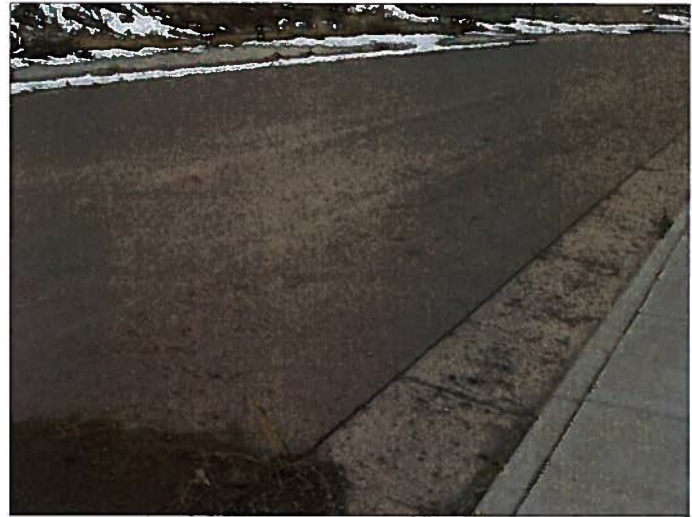
Comp #: 401 Asphalt - Major Overlay

- The drive asphalt appeared to be in good to fair condition, at time of observation, with nothing significant worth noting. As asphalt ages, oxidation occurs, cracking begins and leads to spalling, potholes, and sinking/rising.
- With proper maintenance, including, but not limited to, annual crack sealing and regularly scheduled surface applications like seal coating, slurry sealing and patching, these surfaces will last for some time.
- Please use the funds from 402 to help fund for the milling and overlay outlined in this component.

\$1.75/GSF; Estimate for milling and 2" overlay

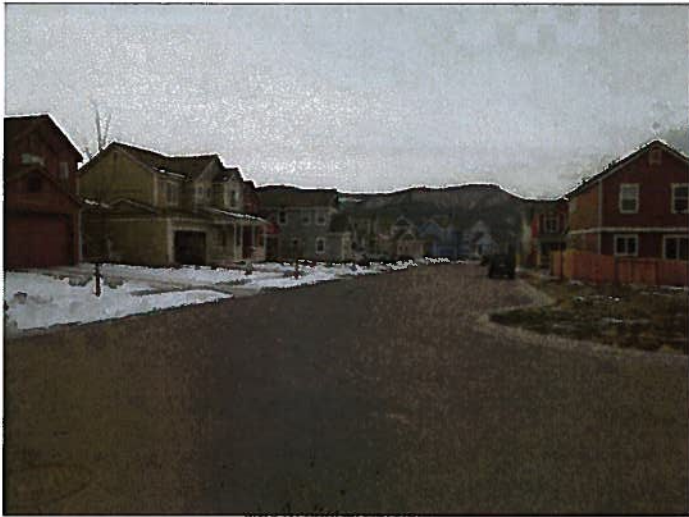
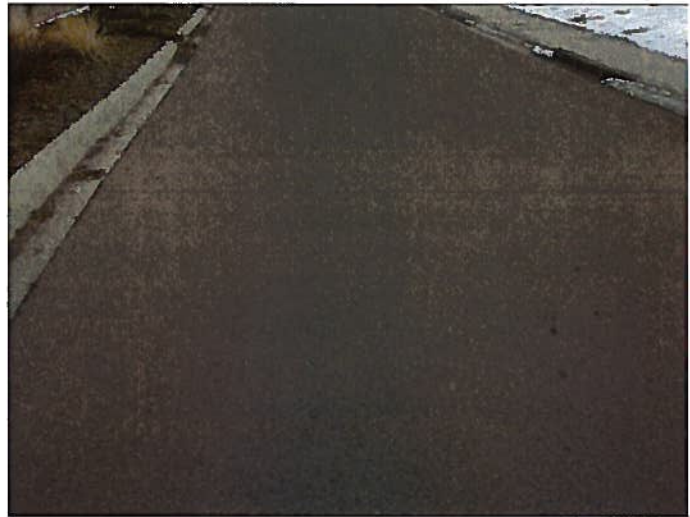
Comp #: 402 Asphalt - Surface Application

- The asphalt surfaces appeared to be in fair to good condition at time of observation with oxidation and cracks noted.
- Typically, in this region, with reported traffic patterns and snow removal techniques, asphalt surfaces need to have regular surface preparation to ensure the longest possible useful life. This can range from seal coats to IR patching.
- The cost and frequency of application will need to be adjusted in updates to match existing conditions.

\$0.18/GSF; Estimate for surface treatment

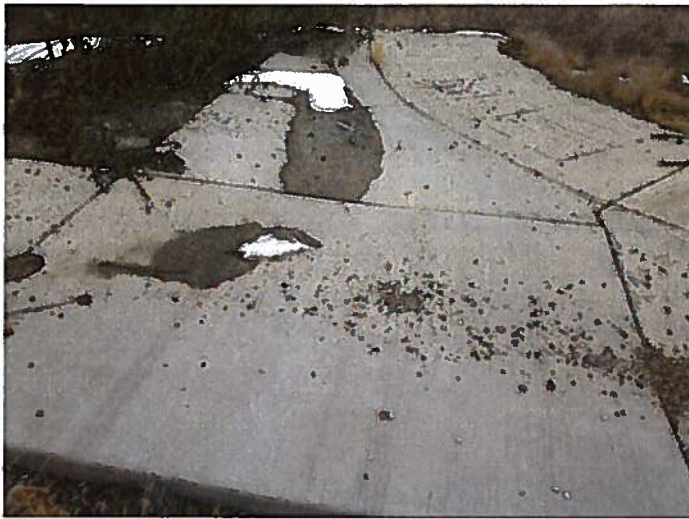
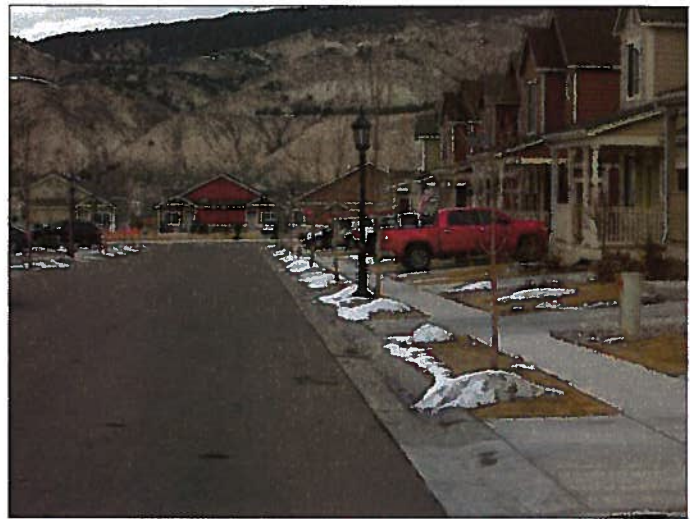
Comp #: 403 Drive Concrete - Repair/Replace

- The concrete drive surfaces appeared to be in fair to good condition at time of observation with minimal cracking, spalling or other forms of advanced deterioration note during observation.
- Due to different rates of deterioration based on location and traffic patterns, it's difficult to predict when, where and to what degree the concrete will need replacement. We recommend an allowance be provided to make repairs.
- Updates will need to adjust the quantity and frequency of repair to match existing conditions.

Allowance to remove and replace 5% of area

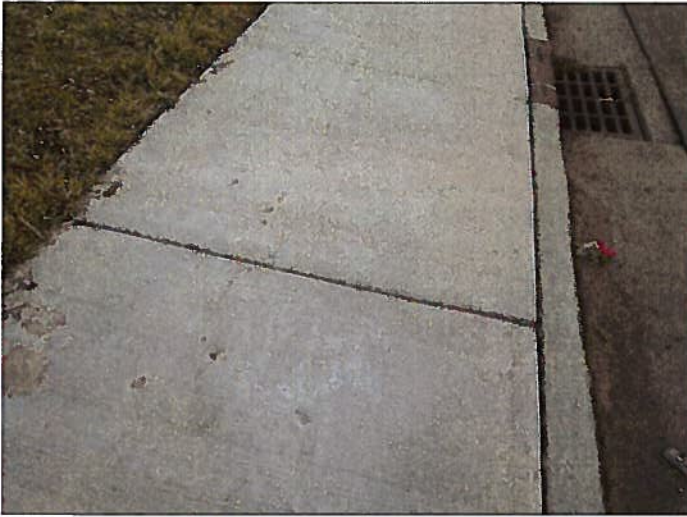
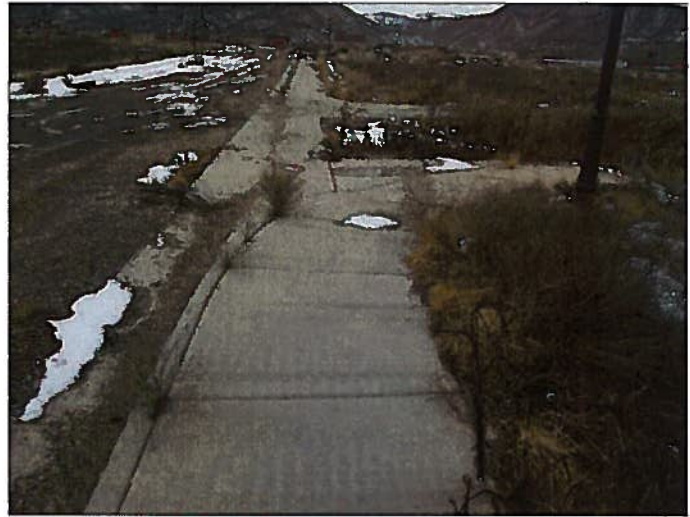
Comp #: 601 Walk Concrete - Repair

- During observation, the walk concrete appeared to be in good to fair condition with minimal deterioration noted.
- As with drive concrete, it's difficult to predict failure in concrete surfaces. As such, we recommend that an allowance be provided to repair or replace a portion of the walk concrete periodically.
- As the concrete ages, deterioration will accelerate and the quantity and frequency of these repairs will need to be adjusted to align with current conditions. This work should be scheduled with other concrete work for best cost.

Allowance to remove/replace or repair 5% of area

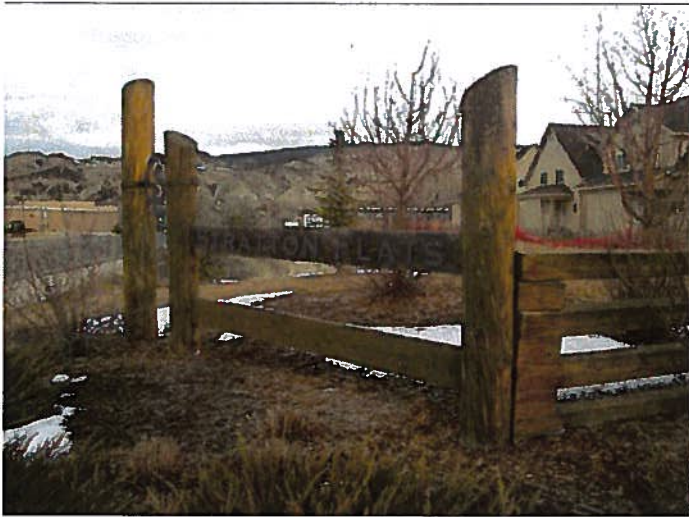
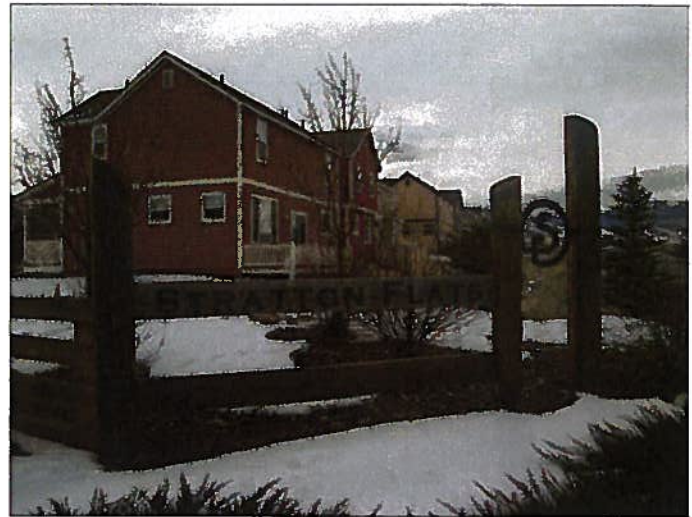
Comp #: 801 Monument - Rebuild

- The monuments appeared to be in good condition with no exposed metal surfaces, or rotting, noted during observation.
- It is recommended that funding is provided to replace monuments periodically to enhance curb appeal and improve branding of the community. The current funding level is to make slight improvements to the existing asset. Funding should be adjusted based on the desires of the

Entry Monuments -
Vertically driven "telephone poles"; tops cut on bias.
Landscaping timbers to provide depth and massing.
Rough hewn timbers for fencing.
7" tall lettering for Stratton Flats
18" diameter brand with association logo.

Estimate to replace monuments with similar

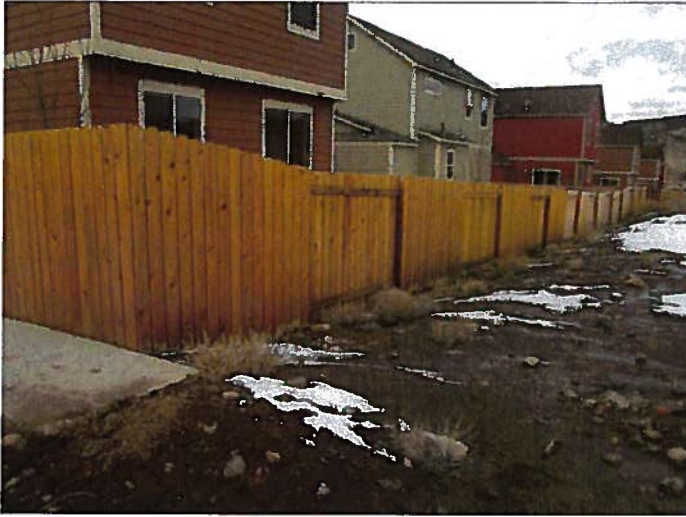
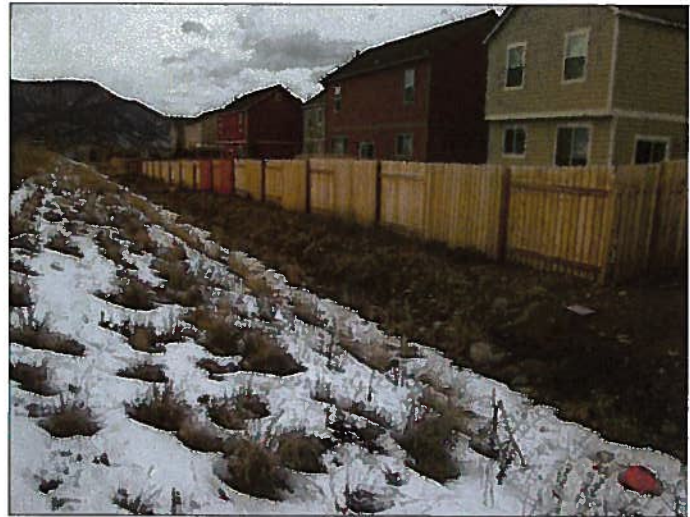
Comp #: 1001 Wood Fencing - Replace

- The fencing appeared to be in good condition at time of observation.
- At this point, the declaration is silent to the maintenance responsibilities of these assets. As such, we are considering them to be part of the single family sites and the responsibility of the owner.
- It is recommended that the maintenance responsibility is specifically addressed by the declarant, during the declarant control period, or by the board, through resolution.

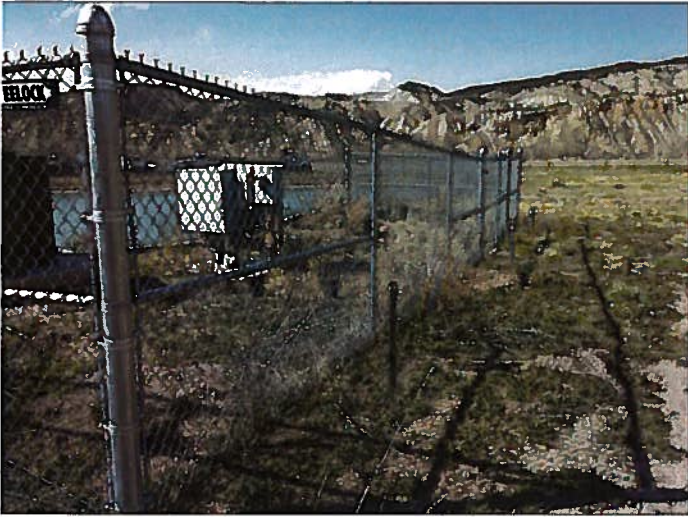
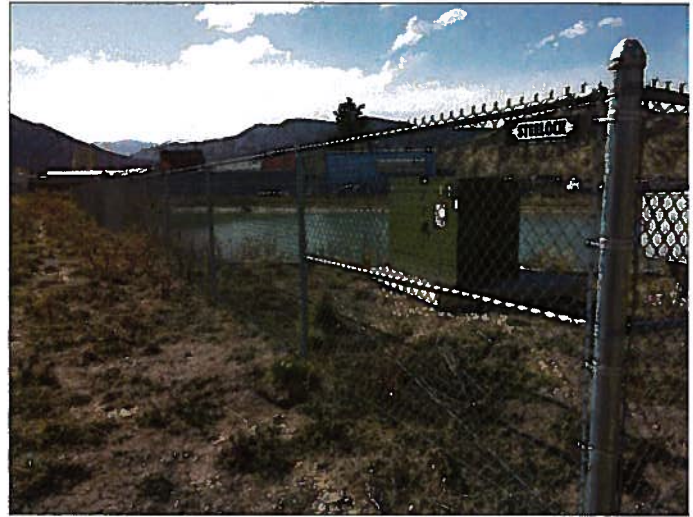
Comp #: 1003 Chain Link Fencing - Replace

- The security fence surrounding the irrigation pond was not observed during site visit.
- It is recommended that funding be provided to replace this fence when the irrigation pond is replaced. Repairs to the fence should be made as needed with operating funds.

**Security Fence -
6' chain link fence
(2) - 6' gates to allow vehicular access**

Best Cost: \$21,525
\$35/LF; Estimate to replace with similar

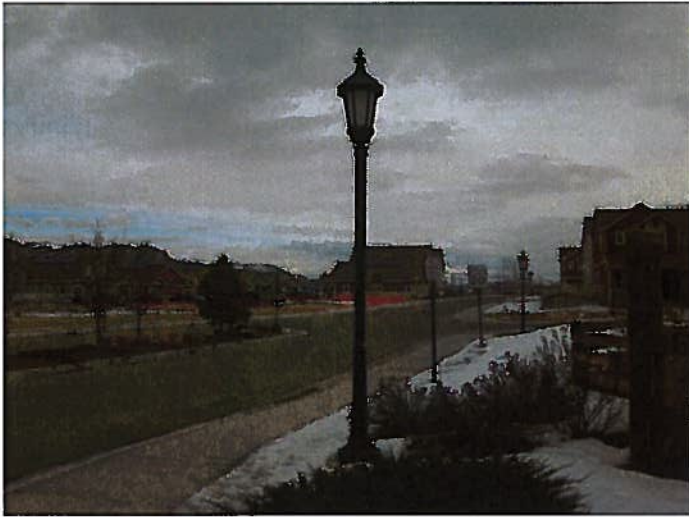
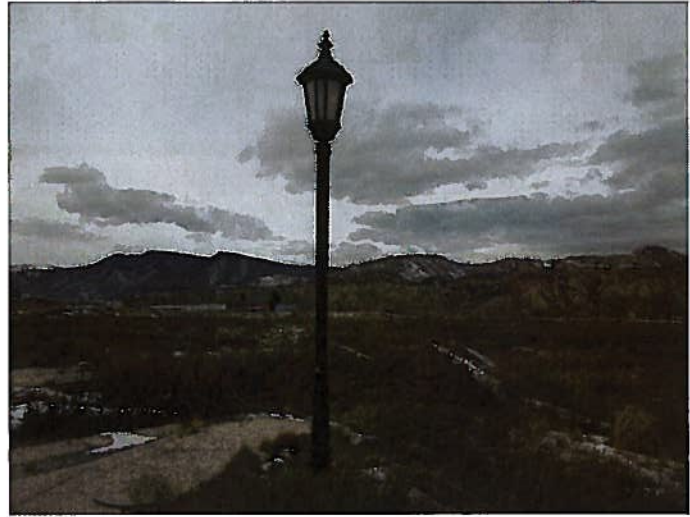
Comp #: 1609 Street Lights - Replace

- The lights appeared to be in good condition during observation with no issues noted. It was reported that all lights are functioning properly as lights weren't observed during dark hours.
- Though the streetlights have been numbered for town management, it was reported that the town has not accepted responsibility for the lights. As such, funding should be provided to replace all lights in the future.
- If new, town acceptable, lighting is installed in future phases, these lights should be replaced and funding changed.

Best Cost: **\$6,000**
\$500/light; estimate to replace with similar

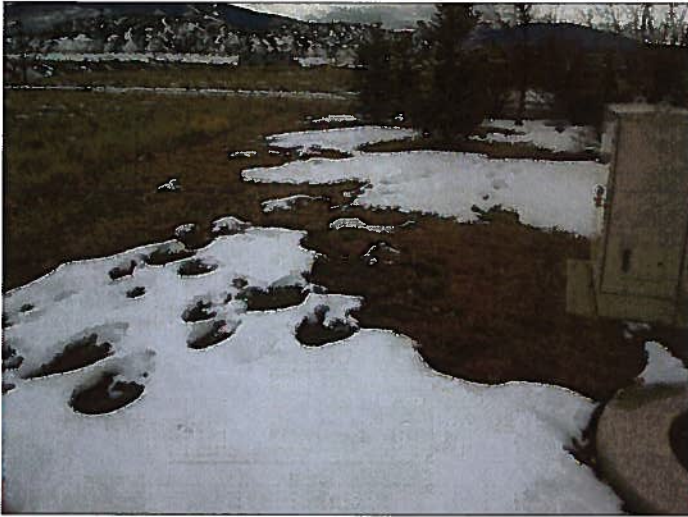
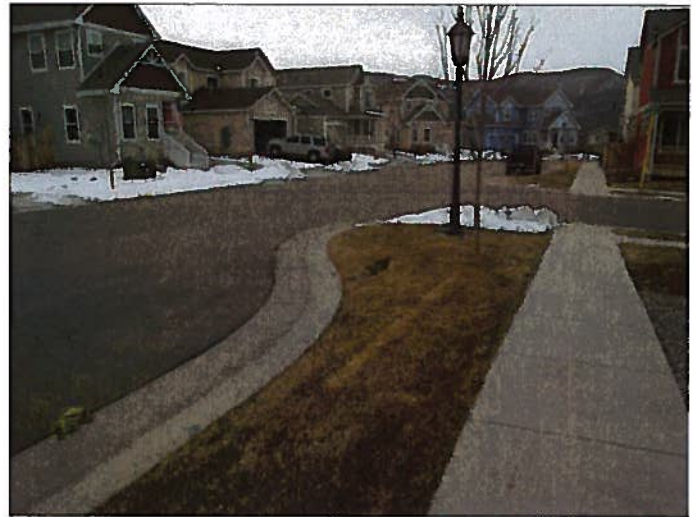
Comp #: 1701 Irrigation System - Rebuild

- The irrigation system was not observed due to time of year when property was visited.
- It was reported that the irrigation system installed by the original developer has significant issues that need to be addressed. However, these issues are being addressed and the new developer is installing a quality product.
- It is recommended that funds are provided to perform major repairs to the originally installed system until the current issues are remedied. After that, funding is necessary to make repairs to an aging, and deteriorating, system.

Estimate for major repairs and renovating system

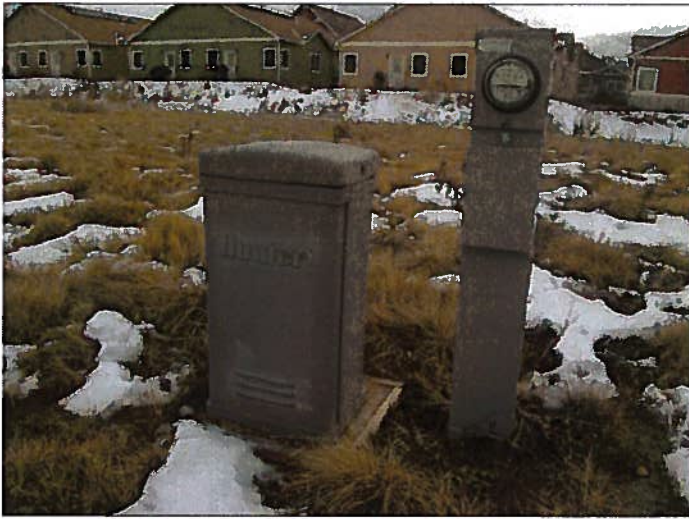
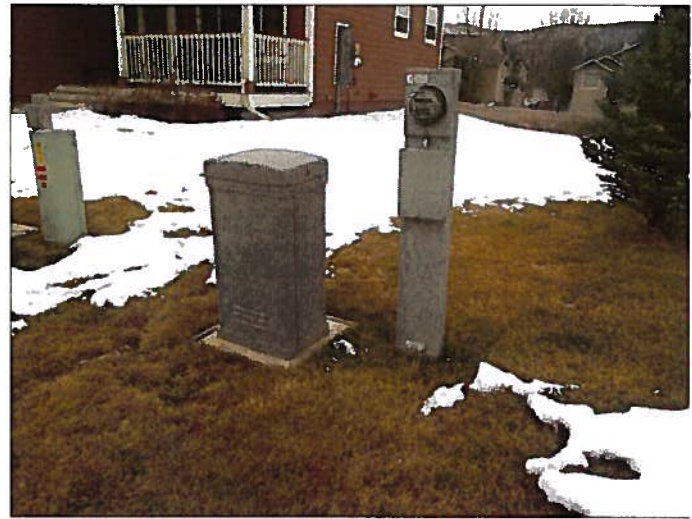
Comp #: 1703 Irrigation Controllers - Replace

- The irrigation controllers appeared to be in good condition at time of observation with no current problems noted or reported. Controllers weren't observed in operation due to time of year during site observation.
- It was reported that the first controller installed was improperly grounded and burnt through 2 controllers shortly after installation. This problem was fixed and the controller should have an average useful life of 10 years.
- Updates will need to address when new controllers are installed and adjust replacement cycles.

**Irrigation Controllers -
 SW corner of Sunny and Stratton -
 (1) Hunter Controller
 S side of undeveloped portion of Nighthawk Cir
 (1) Hunter Controller**

Estimate to replace with a similar controller

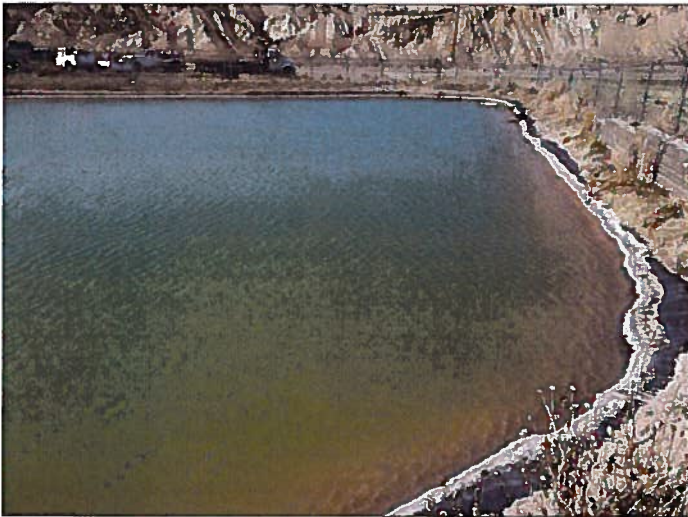
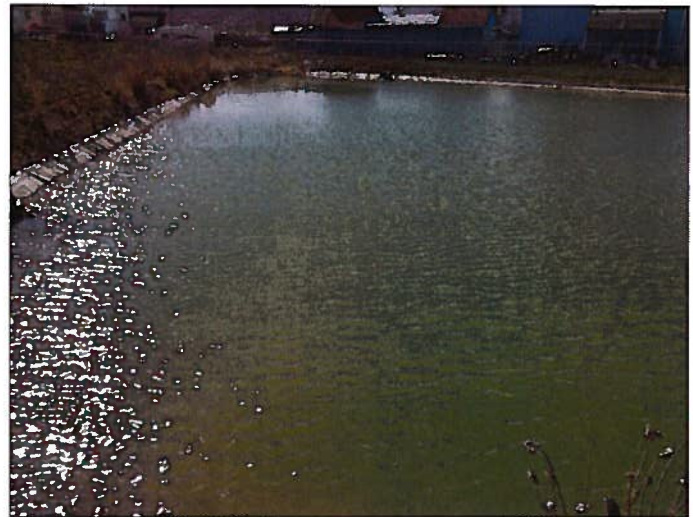
Comp #: 1704 Irrigation Pond - Replace Liner

- It was reported that a covered liner was installed. However, observations showed an exposed liner surrounding all shores. This is typical in that covered liners are seldom maintained properly, drastically reducing the life of the liner.
- Proper maintenance includes, among other things, ensuring this liner is always covered with 12" of earth to prevent UV degradation. The useful life of approx. 50 years could be reduced to 30 - 35 years if not maintained.
- It is recommended that a UV resistant liner is installed to reduce ongoing maintenance costs.

Estimate to completely remove/replace liner

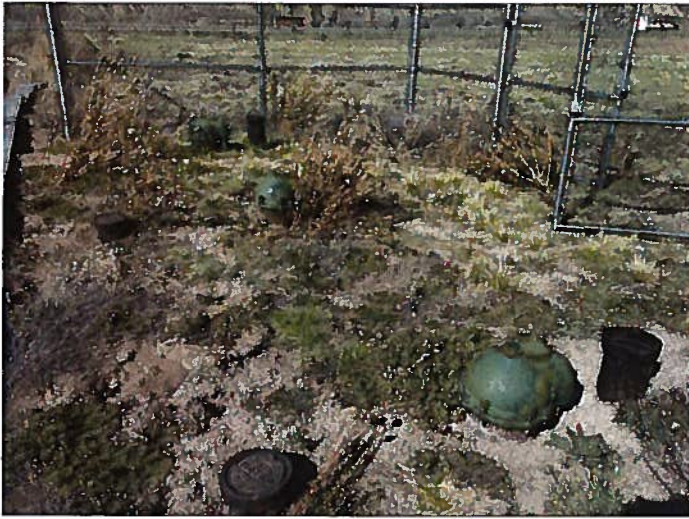
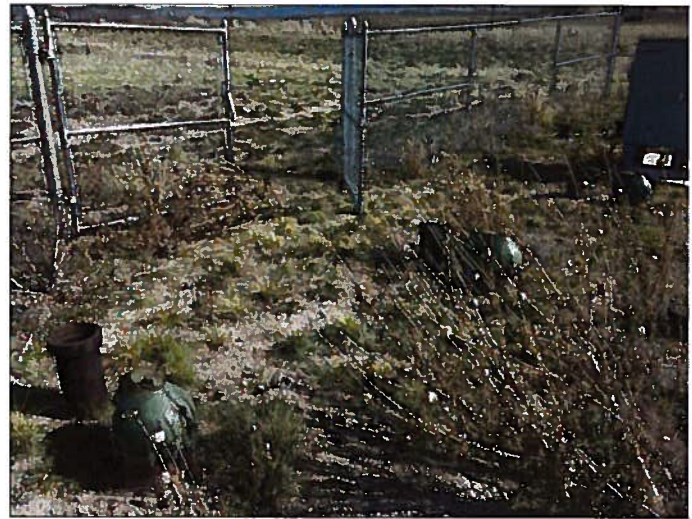
Comp #: 1705 Irrigation Pumps - Replace

- The pumps were not observed in operation during site visit due to time of year.
- It was reported that only 2 of the 3 pumps are operable at this point. However, it was reported that the current irrigation system functions normally with only one pump needed to provide adequate pressure and volume.
- As the system is designed to operate with 3 pumps, it is recommended that 1 pump is replaced every 3 years. This provides for pump replacement every 9 and staggers their replacement to allow for regular replacement.

Estimate to replace (1) pump every 3 years

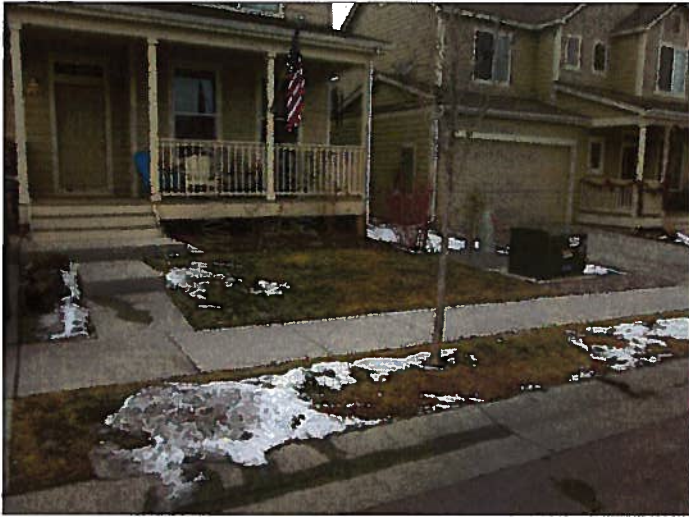
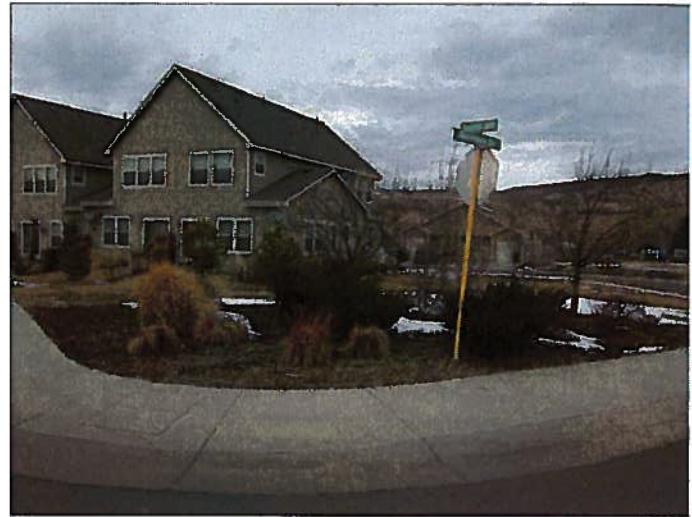
Comp #: 1801 Groundcover/Plantings - Replenish

- The landscaping currently installed throughout the property is new and appears to be taking. All observed landscaping was seen while dormant, but no problems were reported.
- It is recommended that funding be provided to replace dead/dying, or make improvements to, landscaping periodically to ensure a good curb appeal and take advantage of more drought tolerant species as time passes.
- Funding levels and frequency can be adjusted based on the desires of the association.

Allowance to replace/improve landscaping
